The influence of unsealing on the wind resistance of asphalt shingles

This paper addresses the wind-induced tearing and blow-off of asphalt roofing shingles, which are the most frequently observed forms of residential building damage in hurricanes. Field surveys indicate that in-service asphalt shingle sealant strips can lose adhesion along their leading edge over time, leaving the shingle partially unsealed and susceptible to wind uplift. Two interrelated studies presented in this paper show that unsealing is a naturally occurring process and that unsealed shingles are a contributing cause of shingle roof cover damage in high winds. The first study quantified the number, location, and failure mode of laminate and three-tab style shingle systems installed on residential buildings at 30 sites in Florida and Texas. Systematic patterns of partially unsealed field shingles found on 22 of the 30 roofs resembled spatial patterns of wind-induced shingle damage observed in post-hurricane building performance assessments. As expected, older roofs generally contained more unsealed shingles than newer roofs. The results of the second study link blow-off to partially unsealed shingles. Sevent

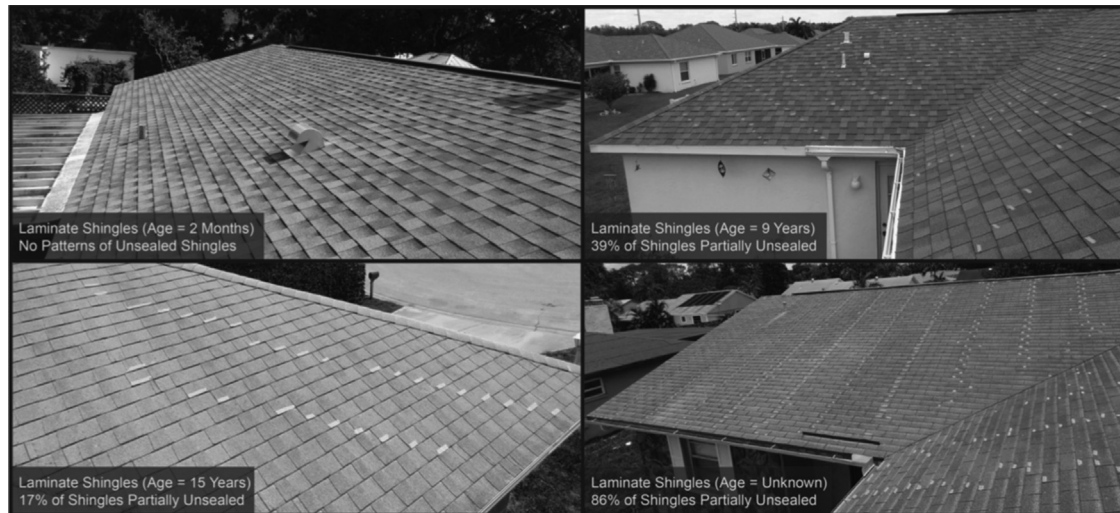
Fig. 4. Tape on roof denotes the location of partially/fully unsealed three-tab and laminate shingles. The pattern of successive courses with unsealed shingles corresponds to the direction of shingle installation (e.g., vertically or diagonally).

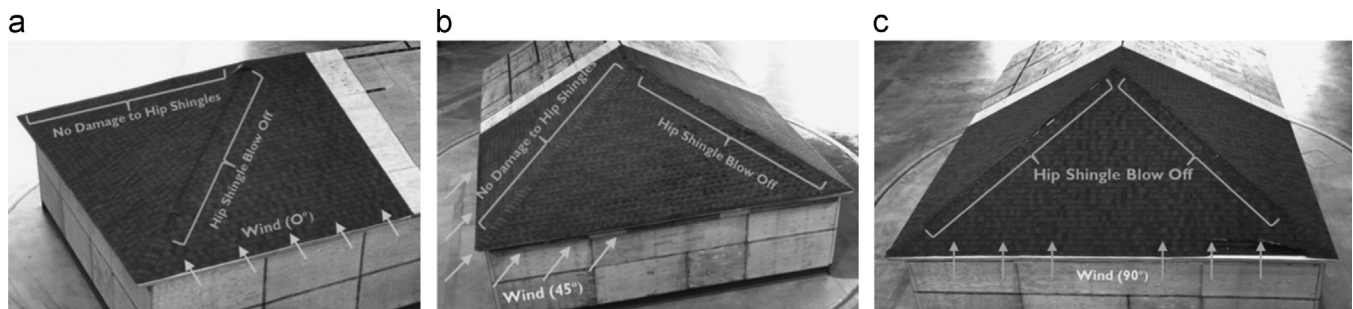
Fig. 17. Characteristic hip shingle blow off patterns: (a) 0°, (b) 45°, and (c) 90° wind directions.

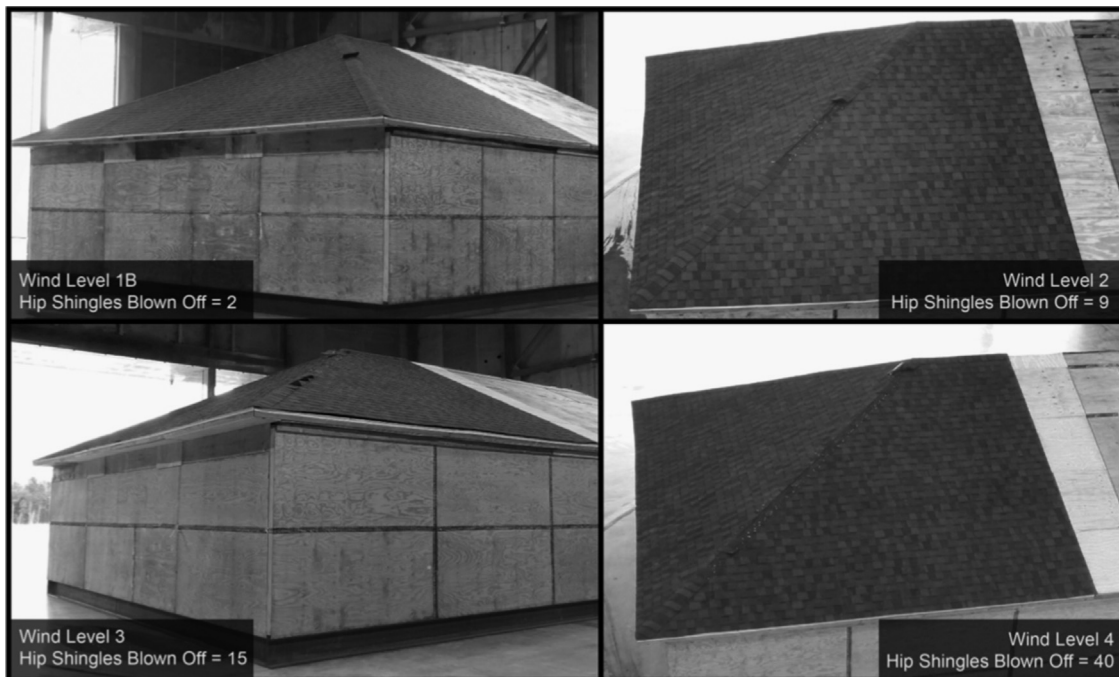
Fig. 18. Progression of hip shingle blow off through the wind test sequence for specimen oriented at the 0° wind direction. This was a typical observation among all hip roof specimens tested.

One example of the progression of hip shingle blow off is given in Fig. 18. For this specimen oriented at the 0° wind direction (see Fig. 11), the first loss of hip shingles occurred during Wind Level 1 with the blow off of two shingles (Fig. 18a). The first shingle to lift was identified prior to the wind test as partially unsealed on its windward edge, and blow off occurred after the lifted shingle pulled through the fastener head. Blow off then progressed upwards during Wind Levels 2 and 3 on shingles that were previously adhered directly upslope from the initially blown off shingle (Fig. 18b and Fig. 18c). A pre-wind partially unsealed hip shingle also blew off towards the bottom of the roof during Wind Level 3 causing progressive blow off through Wind Level 4 (Fig. 18d). By the end of the wind test, only 10 out of the 50 hip shingles on the windward hip line remained on the roof. Damage vulnerability is, therefore, magnified for hip shingles that are unsealed on their windward edges, and loss of unsealed shingles instigates progressive failure of upwind adjacent sealed hip shingles.
